EPA 550-R-99-003
April 1999

EPA/OSHA JOINT CHEMICAL ACCIDENT INVESTIGATION REPORT

**BPS, Inc.
West Helena, Arkansas**

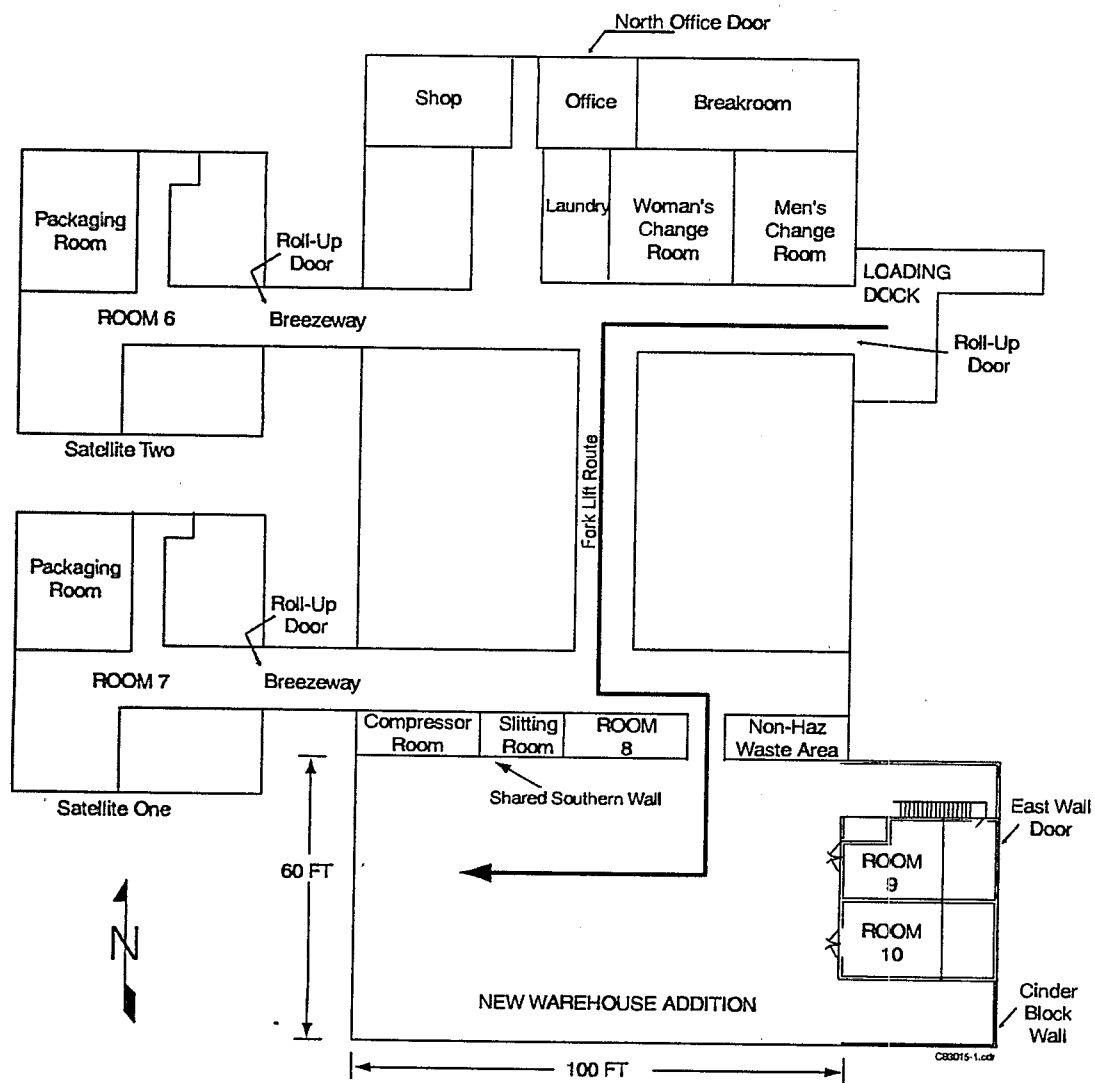
FIGURE 1: FLOOR PLAN - BPS, INC. UNIT #2

The West Helena facility employs approximately 130 workers. At the time of the incident 65 employees were on duty. The facility consists of two production buildings (referred as units One and Two), two satellite buildings, and a "gel" building. The production buildings are constructed of corrugated metal with steel reinforcement. The Unit Two building (Figure 1),

in which the incident occurred, had a 100' x 150' main area, a 16' x 34' loading dock, and two 50' x 60' satellite buildings connected to the main area by breezeways. In October 1995, a warehouse addition was added to the Unit Two building. It shared the southern wall of the original building (referred to as the new warehouse addition north wall). The addition was approximately 7800 square feet. It was also constructed of corrugated metal with the exception of the outside eastern wall. This particular area had two stories with an exterior (eastern) wall constructed of cinder blocks.

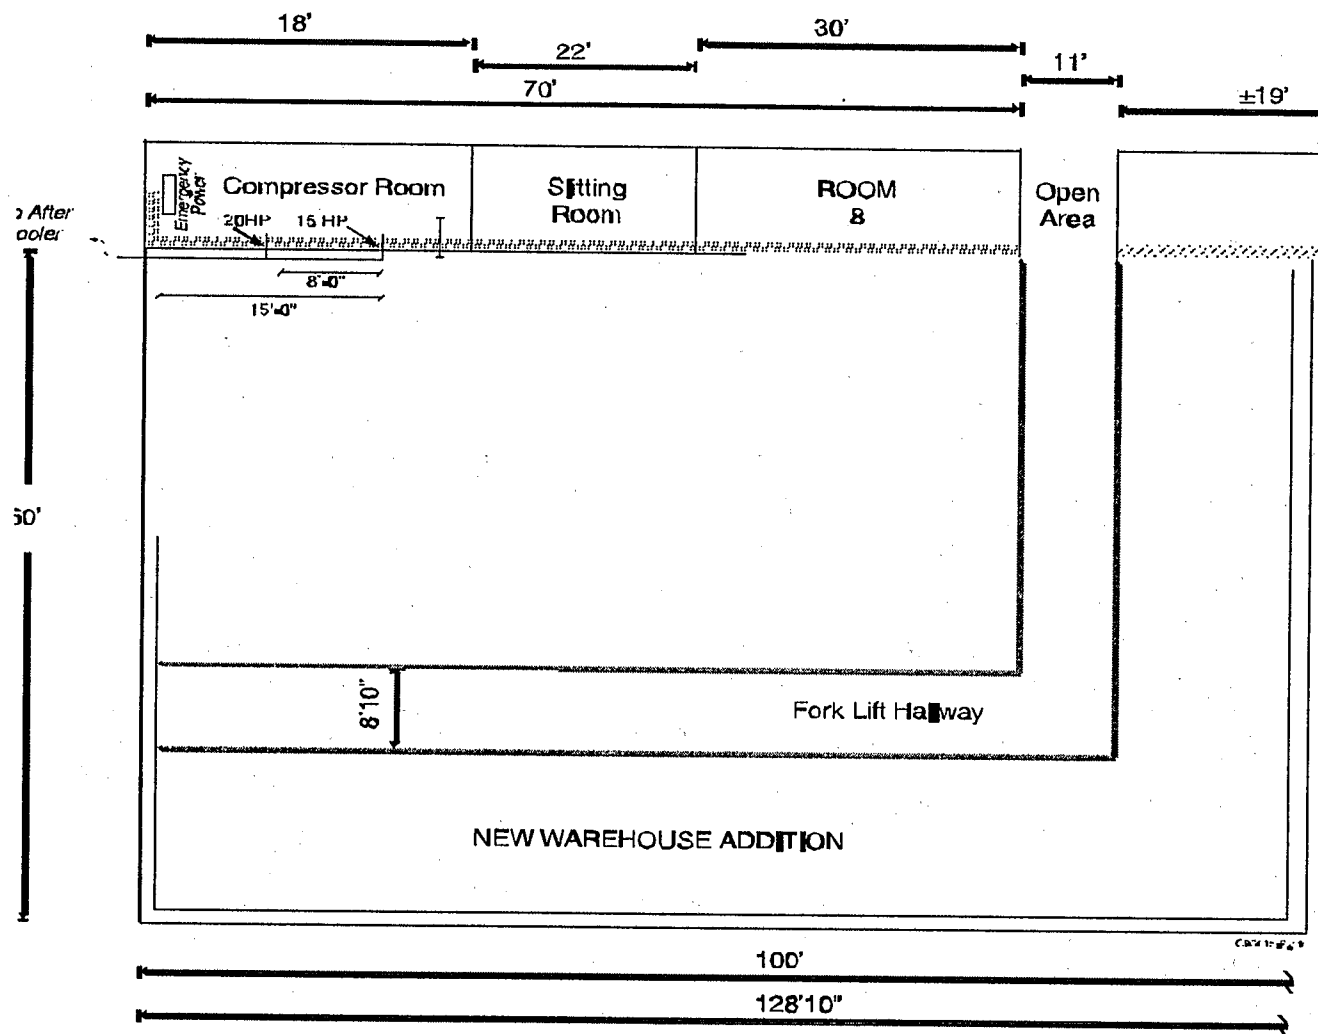
FIGURE 2: NEW WAREHOUSE ADDITION COMPRESSOR SYSTEM

Repackaging operations in the Unit Two building required the use of two reciprocating air compressors. The compressors were located in the southern portion of the original building. The compressors' discharge pipes went through the new warehouse addition's north wall into a common header pipe (Figure 2). This header pipe was fifteen feet long and 5'11" from the concrete pad floor. It ran parallel to the north wall to meet an after-cooler outside the new addition's west wall. The output from the after-cooler was piped back along the same wall 3'7" from the concrete floor carrying the cooled air back to the accumulator tanks under each compressor (Figures 3 and 4).

Two multistage reciprocating air compressors were used in the Unit Two building. As stated previously, these compressors discharged into a common header pipe that was located on the warehouse side of the wall, approximately five feet above the deck. This header was 15 feet long and led to an after-cooler outside the building. The 15-hp unit suffered substantial damage during the incident. After the explosion, this unit was found lying on its side with no lubricating oil in the crankcase. The concrete foundation by the compressor had substantial heat damage and spalling in a configuration that suggested a liquid had burned on the surface. The 20-hp unit had only moderate damage, remained in its upright position after the event, and had a substantial amount of oil in the crankcase.

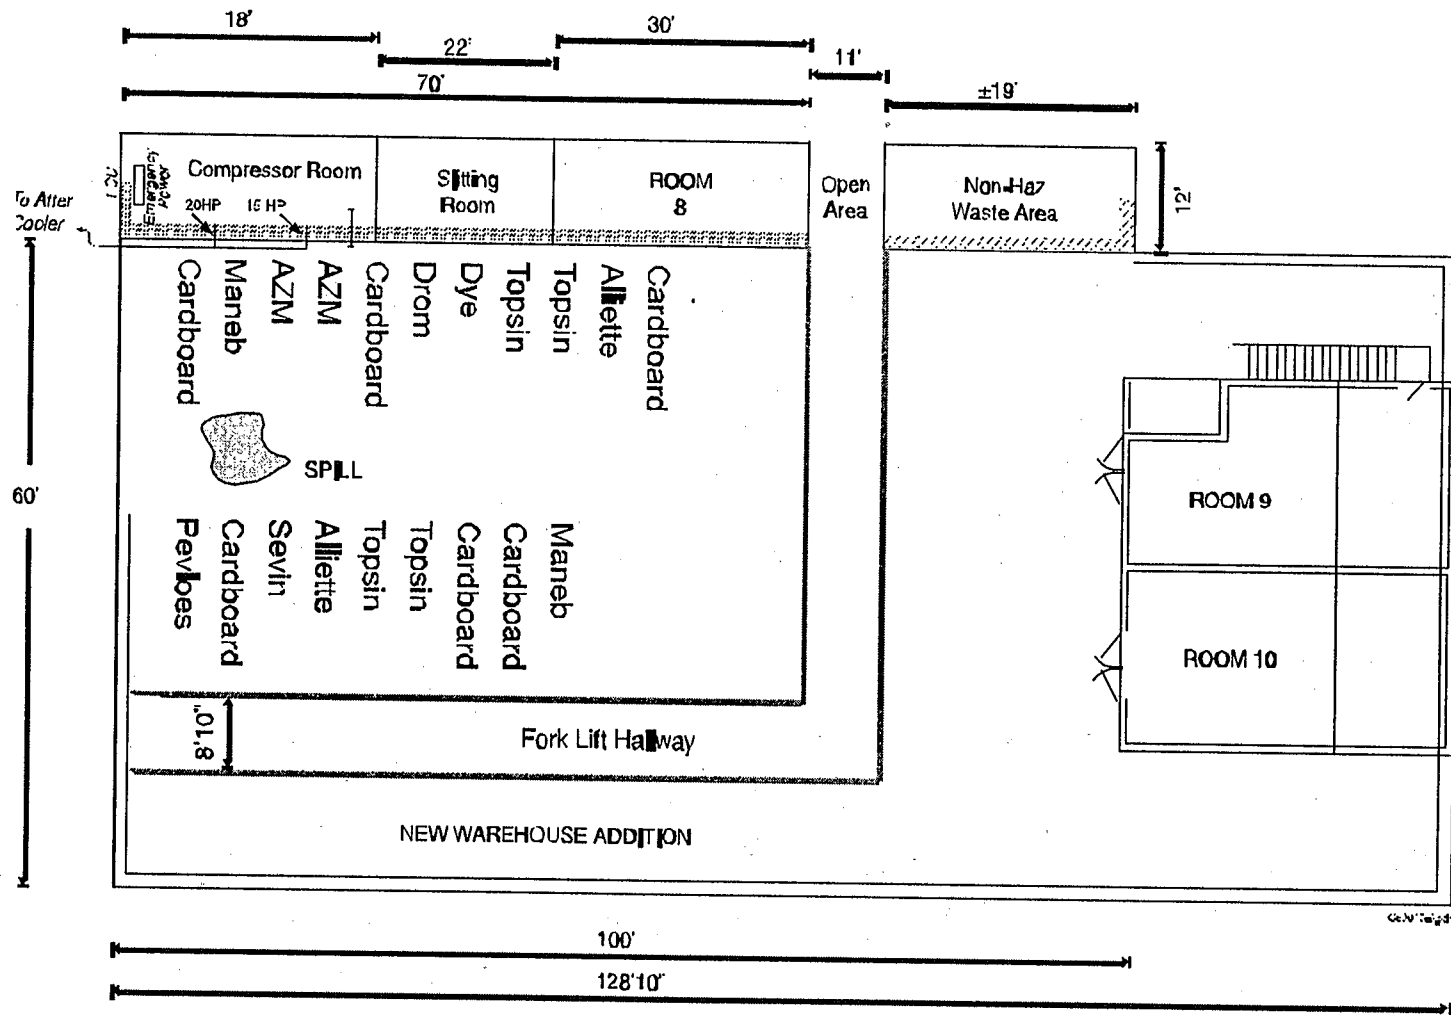
FIGURE 7: APPROXIMATE LOCATION OF CHEMICALS IN THE NEW WAREHOUSE ADDITION.

Based on witness interviews, the JCAIT identified the approximate location of the chemicals in the warehouse area (Figure 7). Even though witness accounts are somewhat conflicting regarding the quantity and approximate location of the stored chemicals, most statements agree that AZM supersacks had just been placed next to the compressor piping. Witnesses also agree that the yellow smoke or powder was coming from this location. Forklift operators recollect placing Maneb pallets by the compressor pipe in an attempt to make room for the incoming AZM. In addition to the witness statements the JCAIT:

- Screened the bulk residue samples for various pesticides including AZM, Maneb, Topsin, and Sevin. Only semi-quantitative values of AZM and Maneb were reported.
- Secured and analyzed the remains of the new warehouse addition ventilation fans which had visible yellow residue (Figure 8). AZM and its major decomposition products were confirmed.

The JCAIT concluded that it was highly probable that pallets of both AZM and Maneb were placed along the compressor pipe the day of the event.

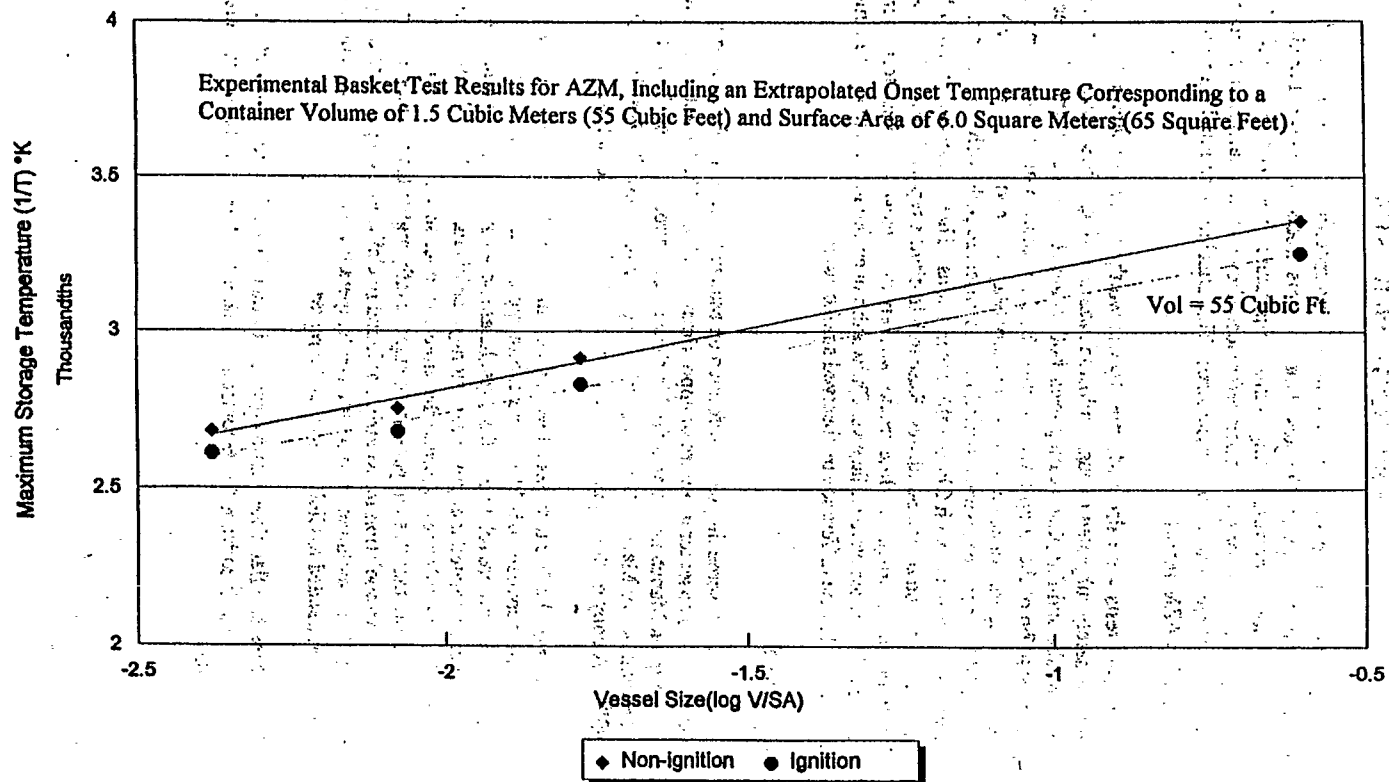
Basket Test

- A basket test to determine safe storage temperatures for bulk AZM 50W showed decomposition of the sample beginning between 158°-176° F (70°-80° C). The decomposition temperature corresponds to an estimated safe storage temperature of 79° F (26° C), using a 10% safety factor, based on volume and surface area specifications for supersacks provided by MFC. It should be noted that the test does not predict a safe time interval corresponding to this temperature.

ICF Kaiser - AZM
